Minor Gearboxes

Gearbox Identification

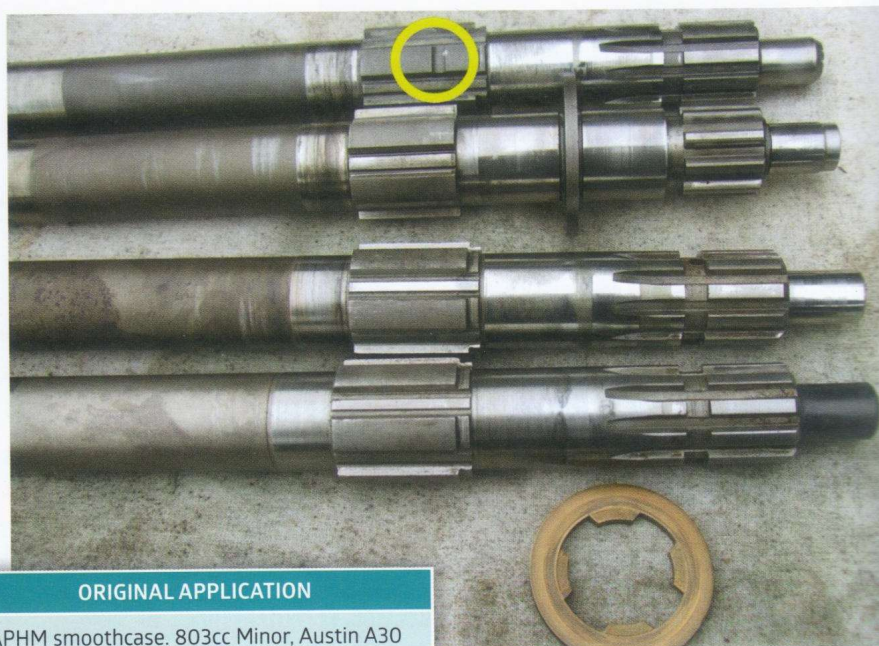
Problems arise when ordering parts, particularly for overseas customers when the additional shipping and import duties are included. Key to avoiding difficulties is in identifying the laygear fitted, as all of the other internals will correspond to this. Not all laygears have the BMC part number stamped on them, so the teeth have to be counted to confirm the gear's identity. I have created the following chart, which should help, along with the subsequent notes.

BMC PART NO	TOOTH COUNT	ORIGINAL APPLICATION
22A288	13;18;23;29	APHM smoothcase. 803cc Minor, Austin A30 (note 1)
22A287	13;18;24;28	9M smoothcase. 948cc Minor, Austin A35, A40, and 9C smoothcase - Healey 'Frogeye' Sprite
22A207	13;19;23;26	9CG smoothcase. 948cc MG Midget Mkl, Austin Healey Sprite Mkl (note 2)
22G083	13;19;24;28	10MA and 10MC ribbed case. 1098cc Minor, Austin A35, A40
22G76	13;19;23;26	10CG ribbed case. Early 1098cc MG Midget (note 2)
22G232 or 22G1100	13;19;23;26	10CC ribbed case. Late 1098cc MG Midget and 12CC, 12CD, 12CE ribbed case. 1275cc MG Midget (note 2)

Note 1: 803cc Morris Minor and Austin A30 internals are the same, except that the A30 mainshaft is approximately 2.5in shorter, to accommodate a different prop-shaft length.

Note 2: Although the Midget laygears have the same tooth counts, they're not interchangeable, as the tooth angles can vary, ie 'A' and 'B' type, and the overall length of the laygear varies by approximately. 0.5mm, depending on whether smooth or ribbed case.

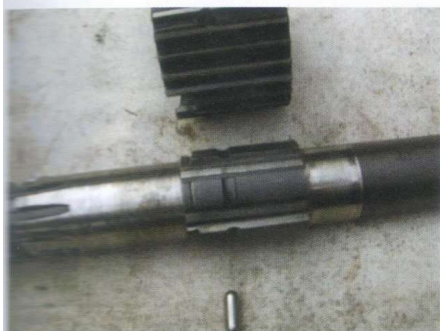
The photo shows the interlocking washer's position between 2nd and 3rd gears when assembled

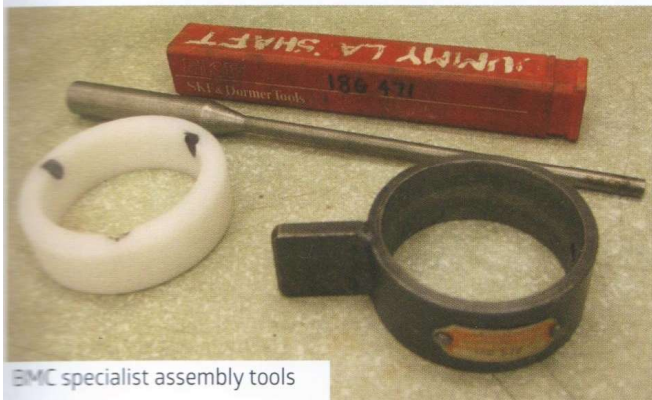
BMC specialist assembly tools

BMC did supply a couple of specialist assembly tools:

18G471 – dummy layshaft: This tool can be used for re-assembly of the laygear, shaft and bearings into the gearbox casing.

18G144/18G572 synchromesh assembly ring:

Supplied to BMC by Churchill tools. This tool is the most invaluable, as it helps greatly with the replacement of the synchroniser springs and balls, otherwise a fourhanded job. The white nylon ring in the photograph is a modern alternative to the Churchill tool. I have highlighted the ball insertion grooves in black.

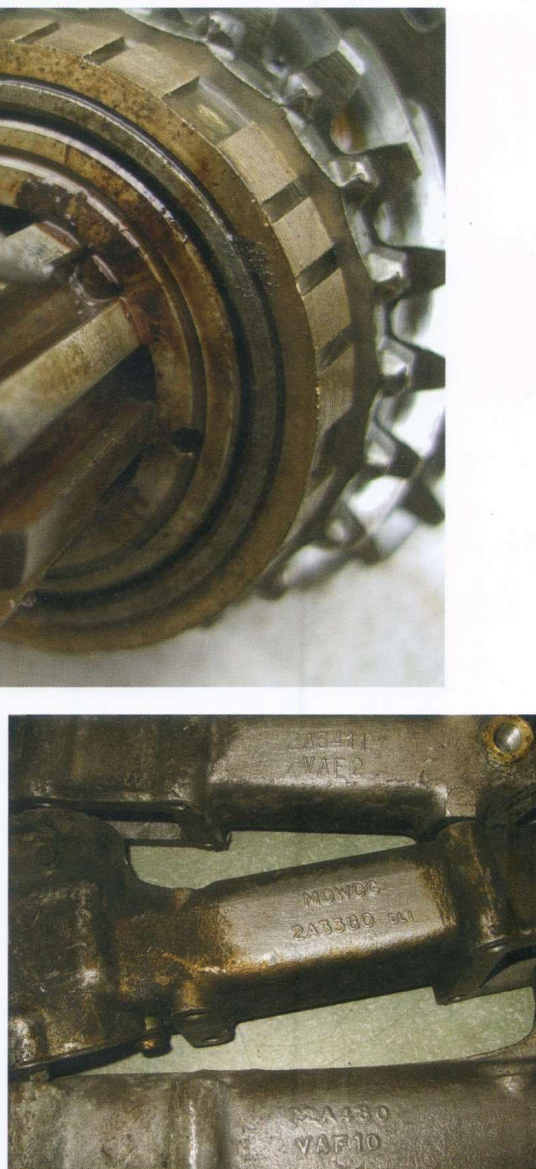
Fitted on later gearboxes, these devices are designed to give a more precise gear change by virtue of a shorter gear lever. Identification can be made by checking the casting number on the left-hand side: 2A3411 and 2A3380 are fitted to 948cc cars, and are not interchangeable with the 'ribbed type' boxes.

Casting number 22A480 appears on the 1098cc Minor, and 1098cc and early 1275cc Midget gearboxes.

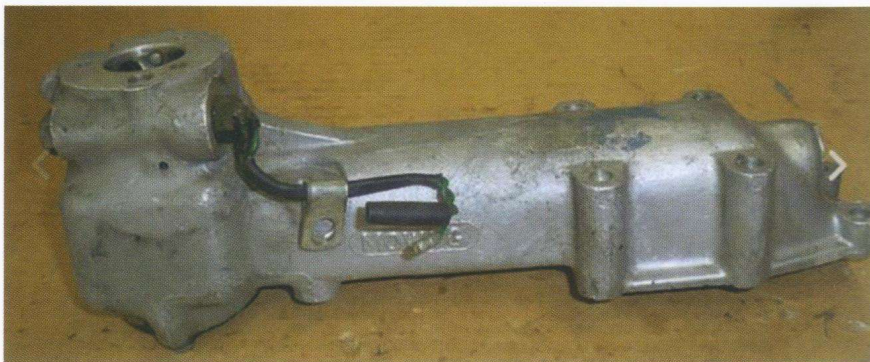
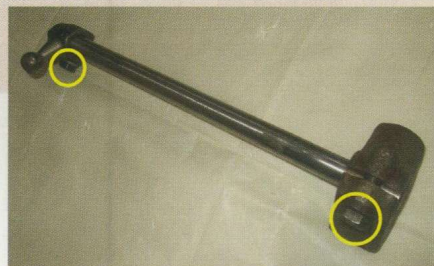
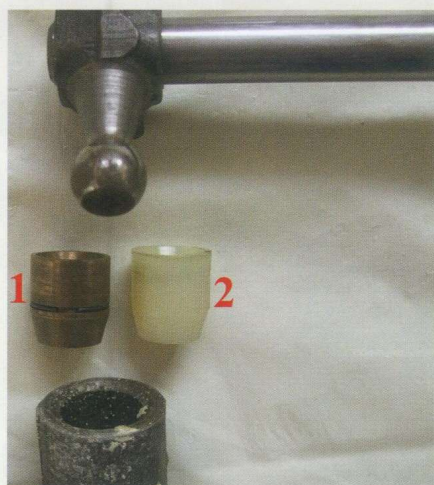
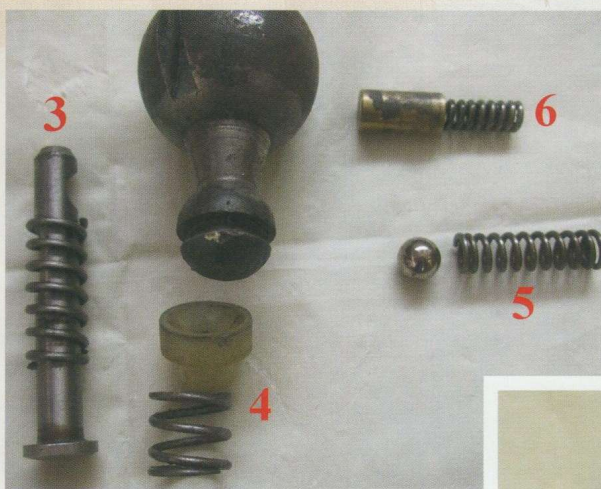
The photo below of the remote linkage with the castings removed shows the extent of the components from the gear lever, via the remote and extension housing levers to the selector rods (that pass through the main casing) shown at the bottom of the photograph. An accumulation of wear in all of these parts will lead to excessive movement at the gear knob.

3/ Plunger and spring – reverse selector 1G3707 and 1G3863

4/ Nylon cup and spring – gear lever seat.

5/ Spring and ball – reverse selector plunger, 22A75 and BLS110

6/ Anti-rattle spring and plunger AEG3123 and 22A84.

Much of the excess gear lever movement will be removed by replacement of the items shown in these photographs.

1/ 2A3377 (two halves) front selector bush (early 948cc) and retaining circlip (1G3709). Superseded/replaced by

2/ 2A3468 nylon one-piece bush (late 948cc, 1098cc and 1275cc)

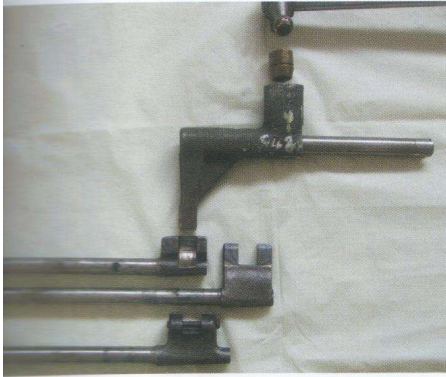
This photo shows the lower half of the selector linkage incorporating the front selector shaft and lever and the ends of the selector rods, contained within the gearbox extension housing. Wear in these components usually requires replacement to eliminate play.

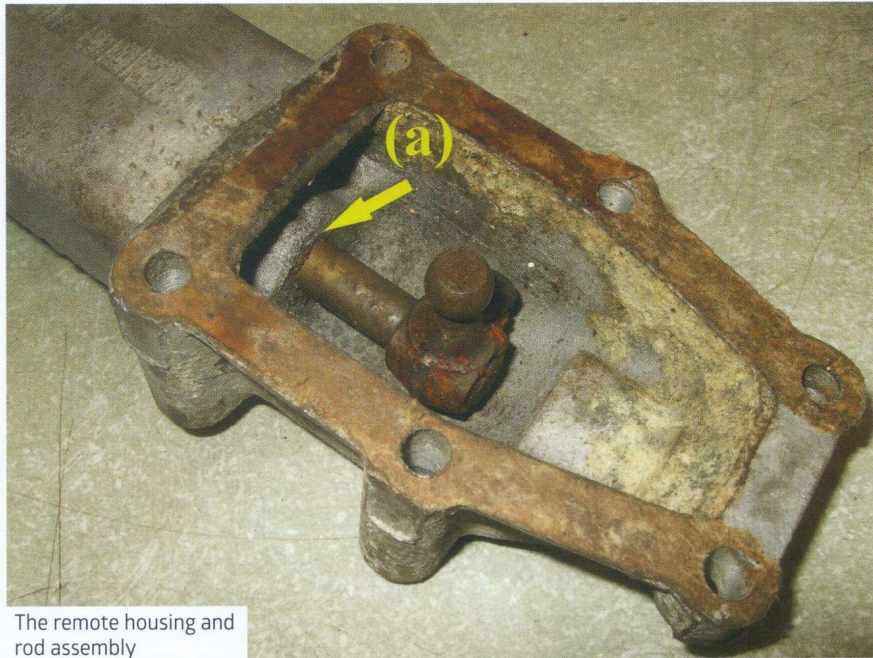
The remote housing and rod assembly

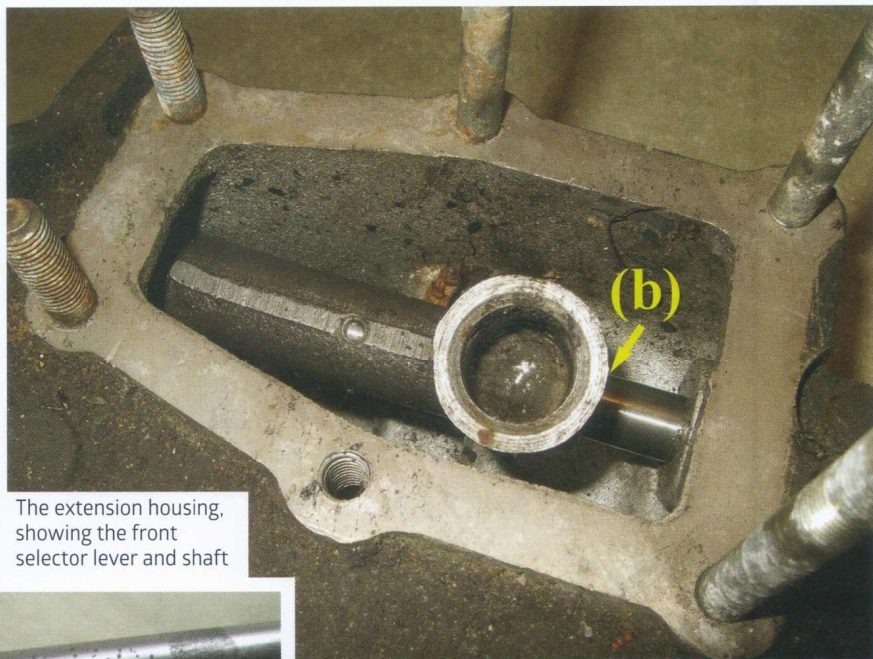
The extension housing, showing the front selector lever and shaft
